Conceptual Model: Connectivity of Hydrogeology at the Haberman Hampton Site to the Musconetcong River¹

17 January 2020

Princeton Hydro, 1108 Old York Road, Ringoes, New Jersey 08551

Prepared for the Musconetcong Watershed Association

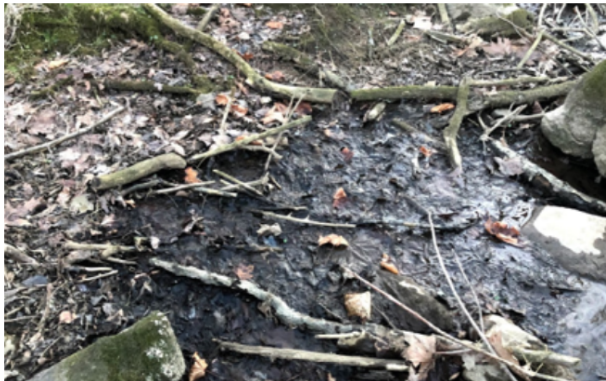
Figure 5: Seep on south bank of the Musconetcong River, 200 feet west of the Haberman Hampton Tract. The seep was emanating about 12 inches above the river water surface at the time of inspection. Date: January 17, 2020.

A site visit conducted to the far side of the Musconetcong River from the Haberman Hampton Tract, and on an immediate, adjacent property immediately to the west of the subject tract on January 17, 2020 revealed several features that further corroborate historic surface, and highly probable current subsurface stream flow to the Musconetcong River from wooded channels connecting the S-shaped dry stream bed closer to Valley Road. Walking along the riverbank on the south/east bank of the Musconetcong River, immediately to the west of the site, reveals streambanks that contain numerous seeps, springs, and channelized flow that emanate from the floodplain of the river. In Figure 5, about 200 feet west of Haberman Hampton, shows a typical seep along the river bank, while Figure 6, another 100 feet to the west, shows a prominent spring that, due to its subsurface source, maintains consistent temperatures that allows vegetative growth even into January.

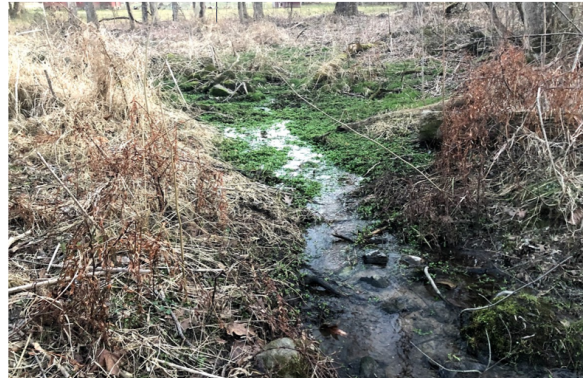
Figure 6: Active spring sustaining vegetation throughout the winter, on the southern bank of the Musconetcong River, about 300 feet west of the Haberman Hampton Tract. Date: January 17, 2020.

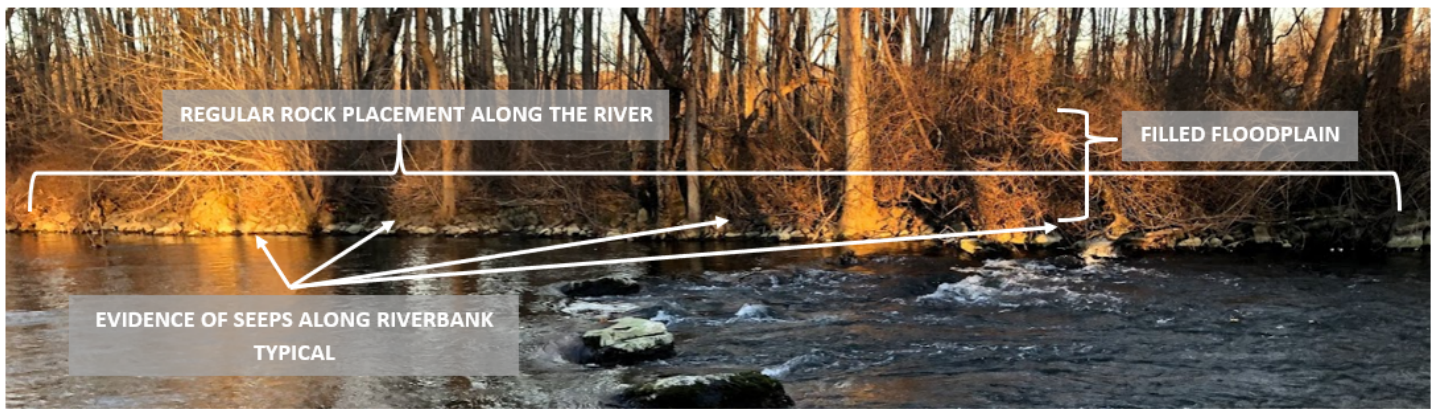
Figure 7: View of south/east bank of the Musconetcong River toward the western area of the Haberman Hampton Tract. Note regular stone placement and filled floodplain and note exposed limestone boulders in river in the foreground. Date: January 17, 2020.

Walking along the northern/western bank of the Musconetcong River, viewing Haberman Hampton banks to the south/east reveal that the riverbanks are lined with rock that, apparently, are man-made (Figure 7) and support a filled floodplain. In viewing the 1931 aerial photograph (Figure 8), it shows that the Haberman Hampton property was farmed all the way up to the edge of the river, and the 1953 photograph (Figure 9) that shows an erosion/deposition fan that backed up and spread across the filled floodplain. It is highly probable that farming became difficult along the river due to karst activity and, subsequently, was abandoned and became wooded. This type of abandonment in areas of active karst areas is corroborated by the observations in the MTA report. Water still runs into the Musconetcong River via the subsurface conduits that remain below the filled surface, as evidenced via seeps observed by MTA and evidence of erosion from these seeps viewed from across the river by the primary author of this white paper.

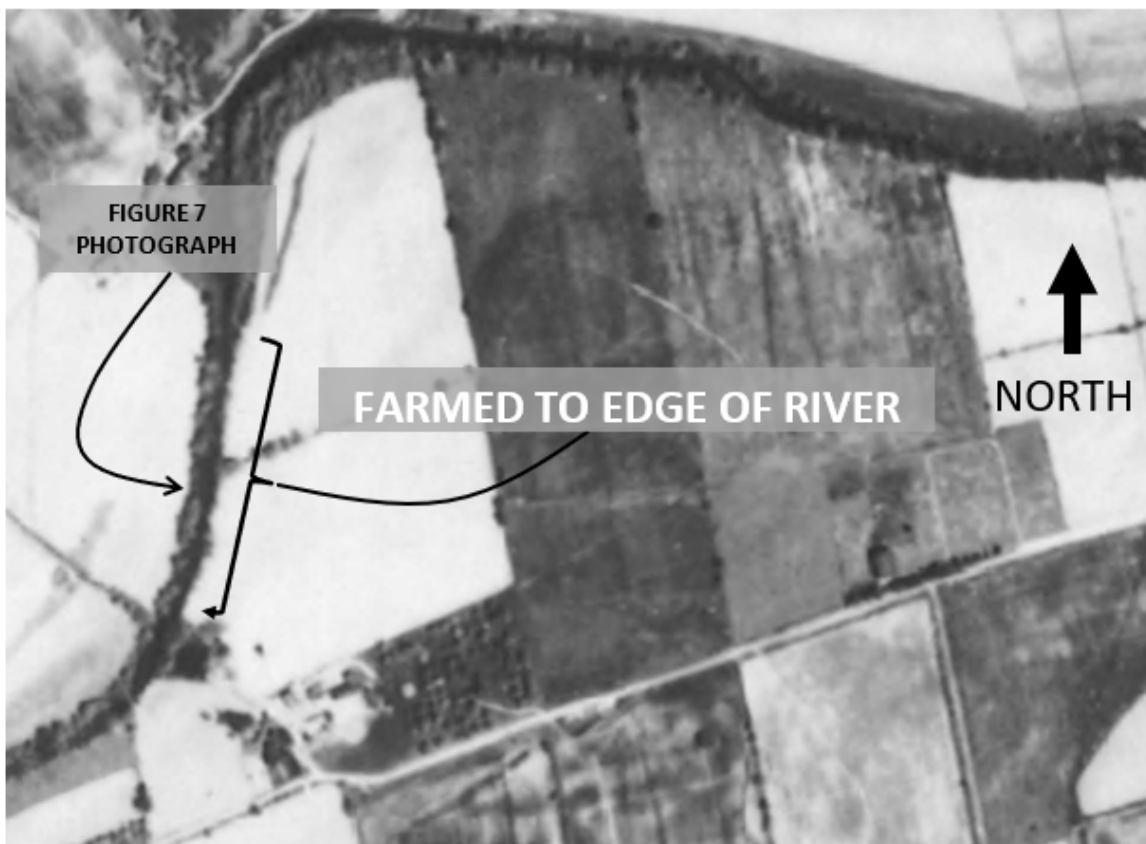
Figure 8: 1931 aerial photograph of Haberman Hampton Tract showing location where farming was practiced to the river edge. Photo source is USDA aerial imagery obtained from historicaerials.com

4. The property has been used for agriculture at least back to 1931, the earliest available aerial photograph, but likely for more than 100 years. The aerial photographic history of the site shows a primary use as row crops. Over the years the site's extent of row crops has changed. The maximum use of the site was observed in the 1931 aerial photograph, and in subsequent photographs wooded areas expanded from those areas less conducive to row crops, and likely a trend away from areas of active sinkhole formation. As a result of annual plowing, planting and harvesting, the drainage on the site has been modified, but there is a tendency for the drainage to reorganize with areas forming streams, then disappearing, and then reforming again, albeit in slightly different configurations. Changing drainage patterns of streams in karst can be rapid, especially as a result of land disturbance, such as acting farming. Such activities will trigger the opening and closing of sinkhole features on a site.
